# INSPECTION REPORT

**999 FOOT CREST SE**  
CALGARY, AB T3R 0A8

Inspection Date: Tuesday, June 25, 2019

Report No. 1013

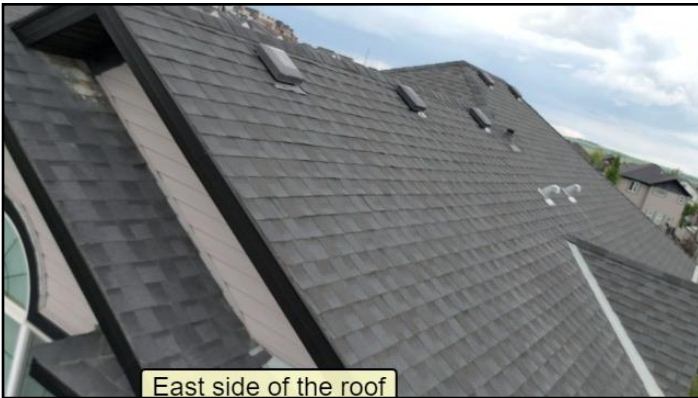
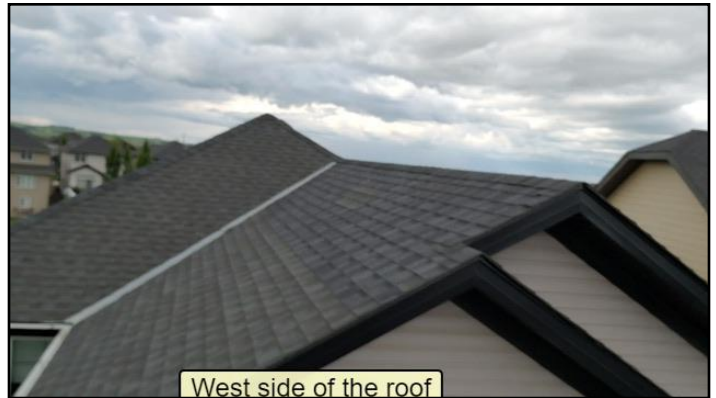
Roof Asphalt shingles, gone through wear and tear for it's age. Few granules were observed in the gutter. No physical damage was observed on the roof cover at the time of inspection.

Asphalt shingles

**2. Condition:** • Roof cover leaks increases exponentially with the age of the covering. Observation of granules in the gutter and mud is indicative of wear and tear of the roof covering for it's age.

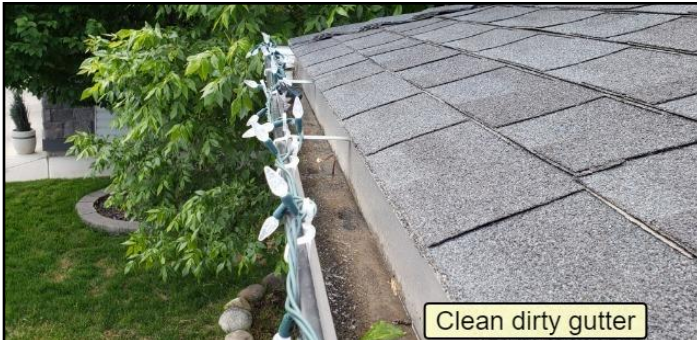
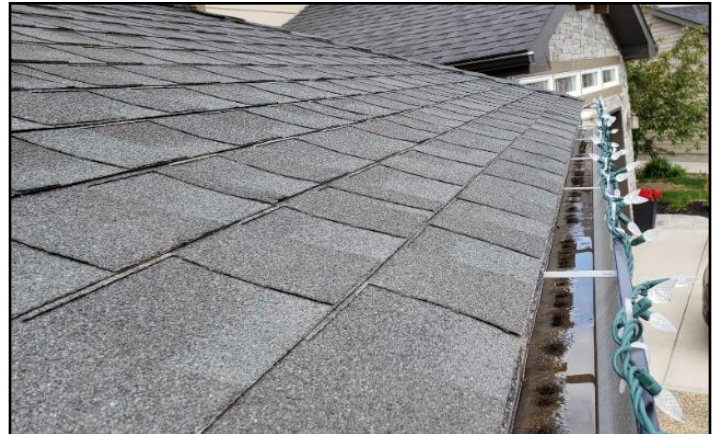
### **5. Condition:** • Dirty/debris

*Dirty/debris*

Gutter should be cleared of dirty for free flow of water to the downspout on the garage roof for free flow of water in the gutter.

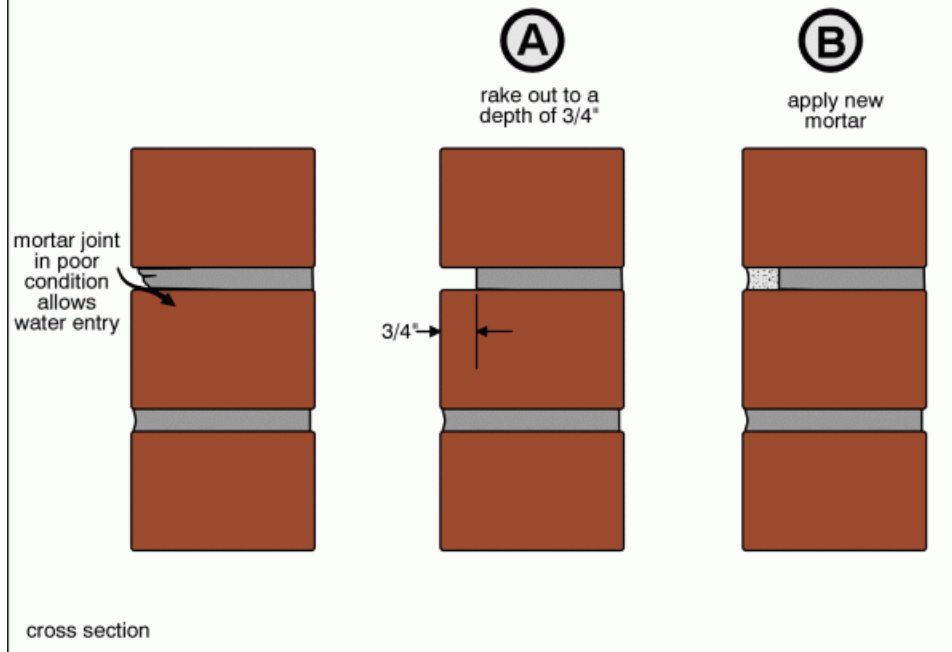
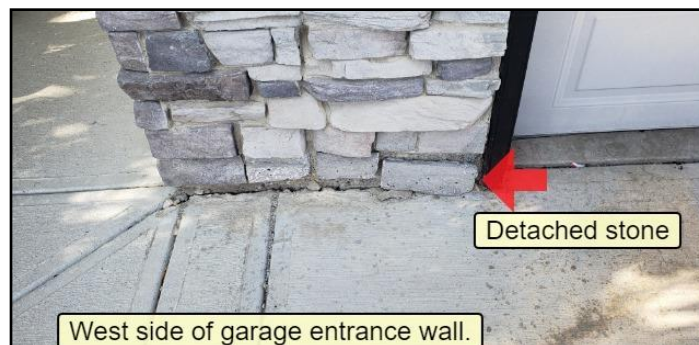
### **6. Condition:** • [Mortar deterioration](#)

Cultured stone is detached. This require repair to prevent water penetration.

Mortar deterioration

## Repointing

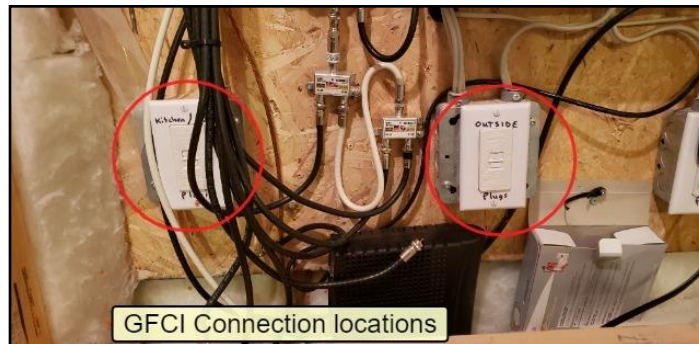
**General:** • The GFCI connections were located below the distribution panel. These were tested at the time of inspection and were found to be functioning.

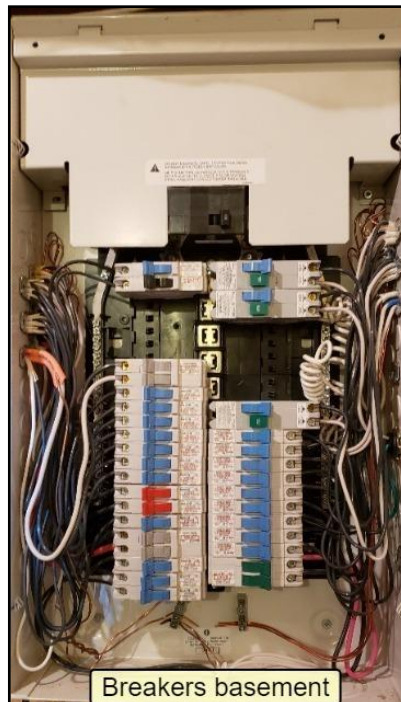
Located On the south east corner of the interior wall of the furnace room.

*Breakers - basement*

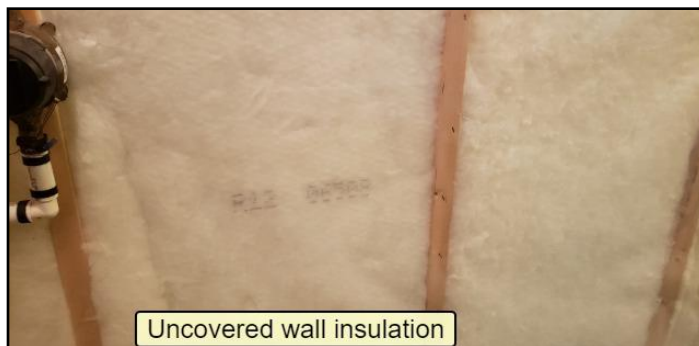
This was inferred by the R12 seen on the glass fiber in the uncovered walls in the basement.

Uncovered wall insulation

R-12

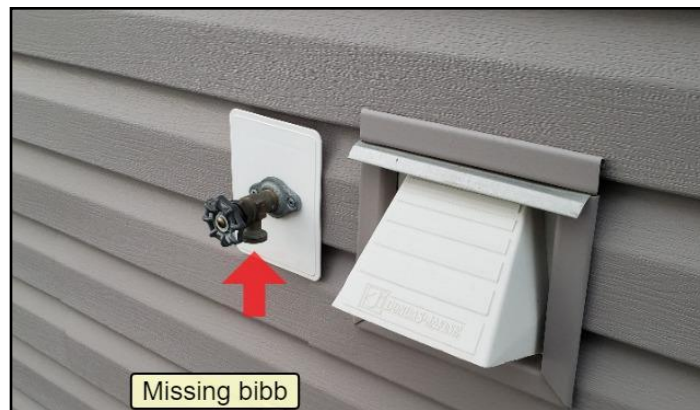
Missing hose bibs on the outdoor faucets.

*Not present*

Missing bibs on the outdoor faucets can cause contamination of the drinking water. Fix bibs to prevent water contamination issues.
